WICKMAN

MACHINE TROUBLESHOOTING.

Wickman Coventry Limited.

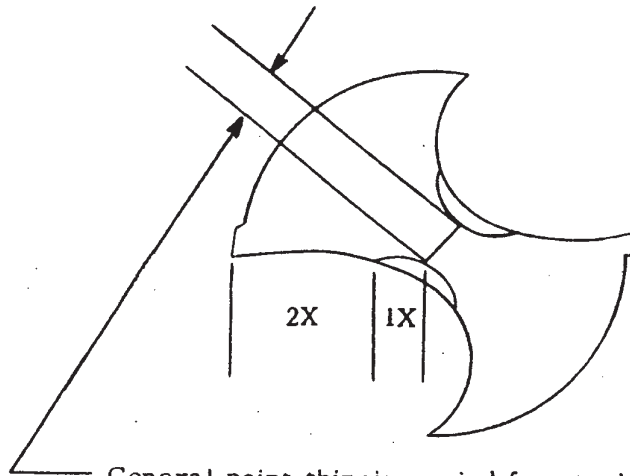
General point-thinning grind for steel.
Width is in relation to drill diameter.

Drill Diameter	Ratio
1/8	20:1
1/2	15:1
1	10:1

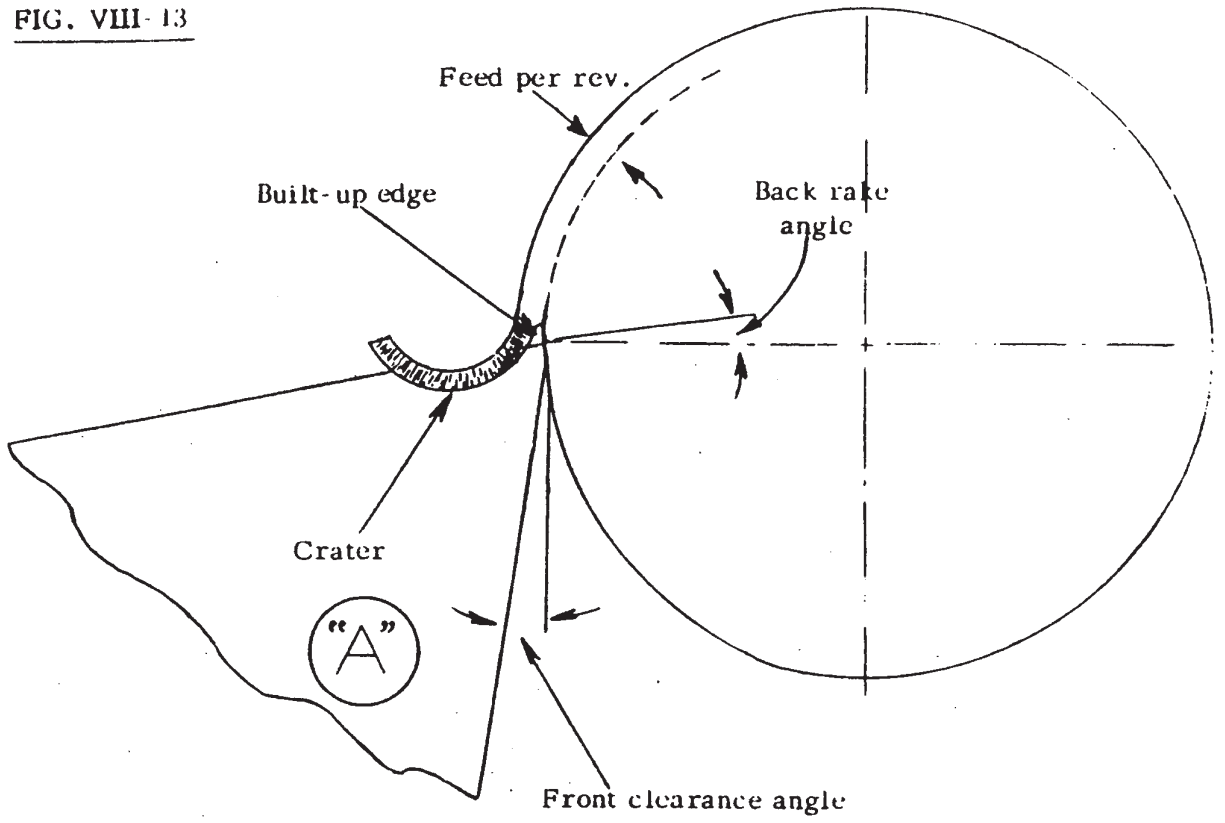
FIG. VIII-13

FORM TOOL DATA

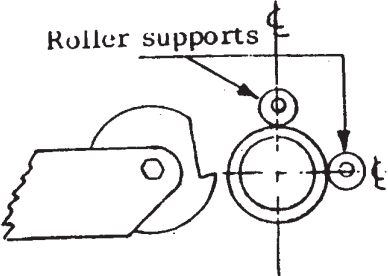
<p data-bbox="225 722 540 810">Relationship of roller support and center line for proper support</p>	Improper tension on stops Tool dull Tool above or below center Part not properly supported Loose spindles Feed per revolution too heavy Machine not locating properly on index	Reset tension Resharpener Reset tool on center Reset support while part is revolving; variation in size of diameter being supported Check and tighten spindle bearings Reduce feed Check and correct condition
Taper on finished part
